# Manhole Inspection Summary

Manhole # S29GG1019MH

Insp Date: **1/4/07 8:39 AM**

**Location** Address: **613 40th ST**

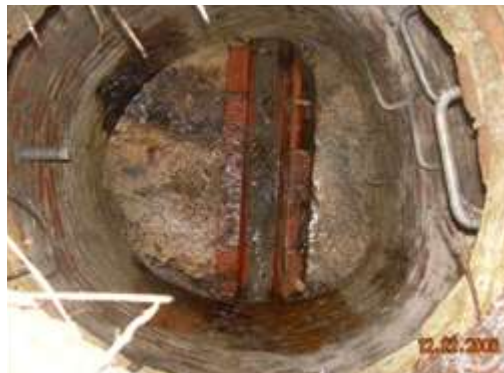
Top View

Barrel infiltration. Bench debris.

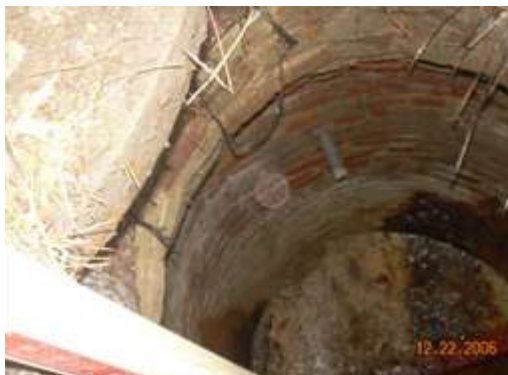
Comments **HEAVY INFILTRATION AROUND THE 2 INCH PIPE COMING THRU THE BARREL  
(Possible illicit connection).**

Possible illicit connection.

2" pipe.

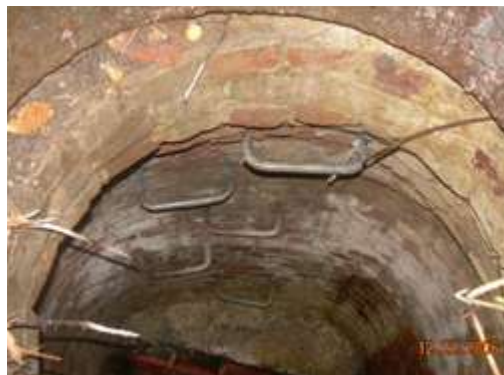
Defect

**Frame** Offset: **3** (in.) Condition: ☒ Sound ☐ Cracked ☐ Leaks

Condition: ☐ Sound ☐ Cracked ☒ **Root Intrusion** ☐ Loose Brick ☐ Deteriorated

Infiltration: ☐ None ☒ **Joint** ☐ Cracks ☐ Mortar ☒ **Roots** ☒ **Wall**

Frame offset. Adjustment root intrusion and infiltration. Corbel and Barrel infiltration.

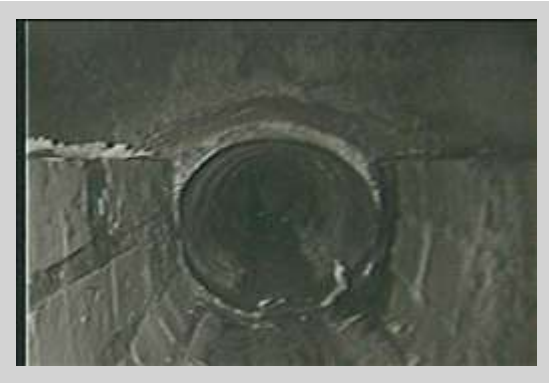
### 8 in. Circular Gravity Sewer Pipe Out @ 12 O'Clock

Infiltration: **Evidence** Pipe Seal Cond: **Unknown**

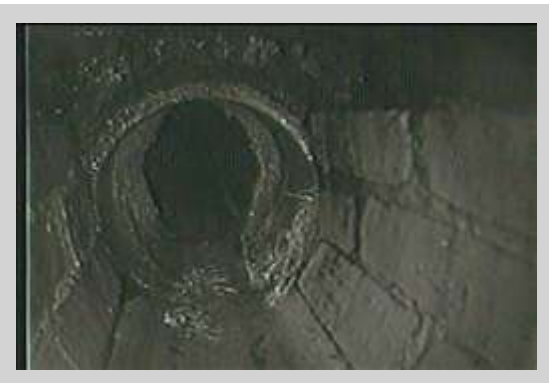
### 8 in. Circular Gravity Sewer Pipe In @ 6 O'Clock

Pipe root intrusion.

Infiltration: **Evidence** Pipe Seal Cond: **Unknown**
